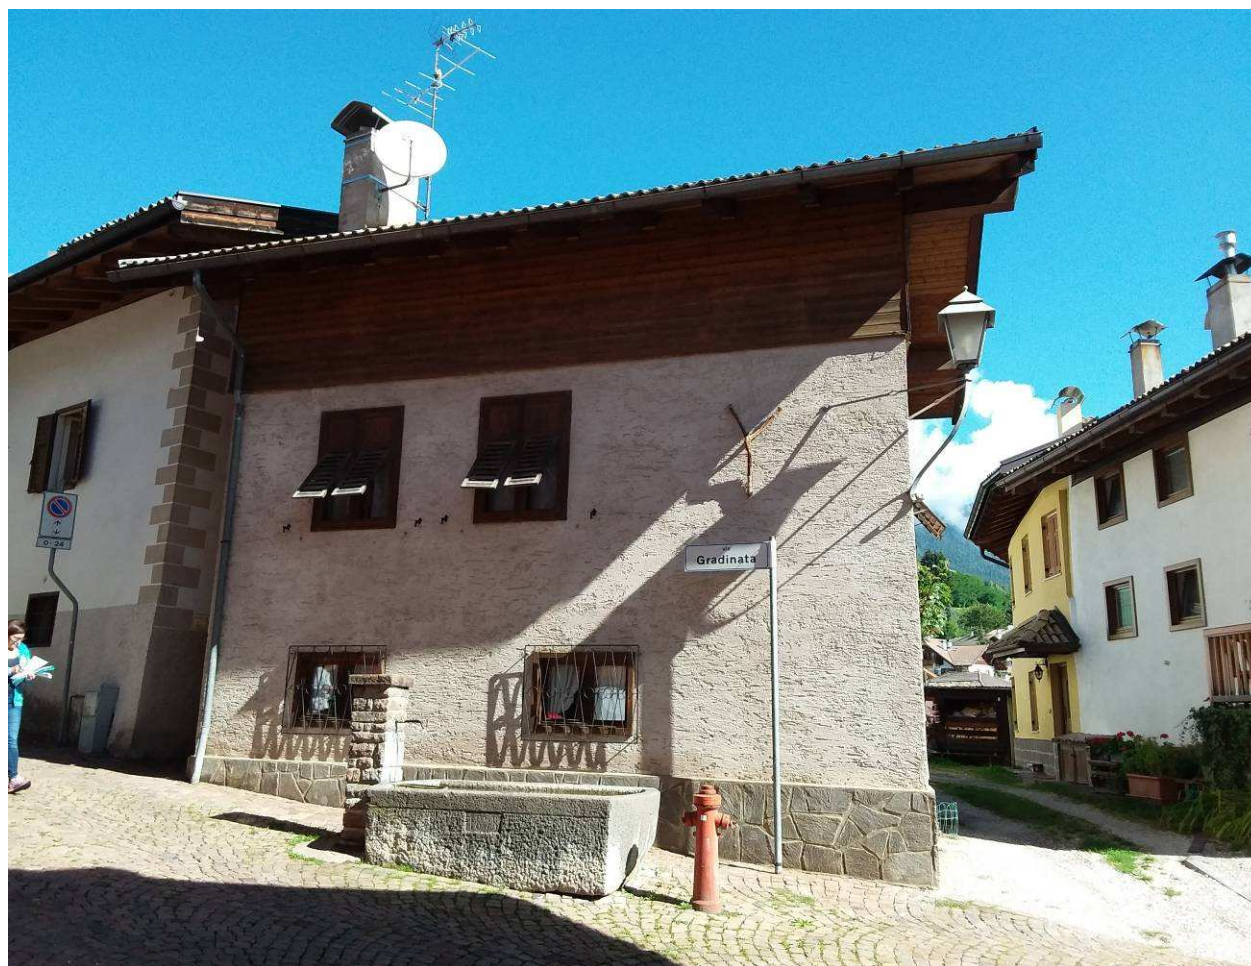
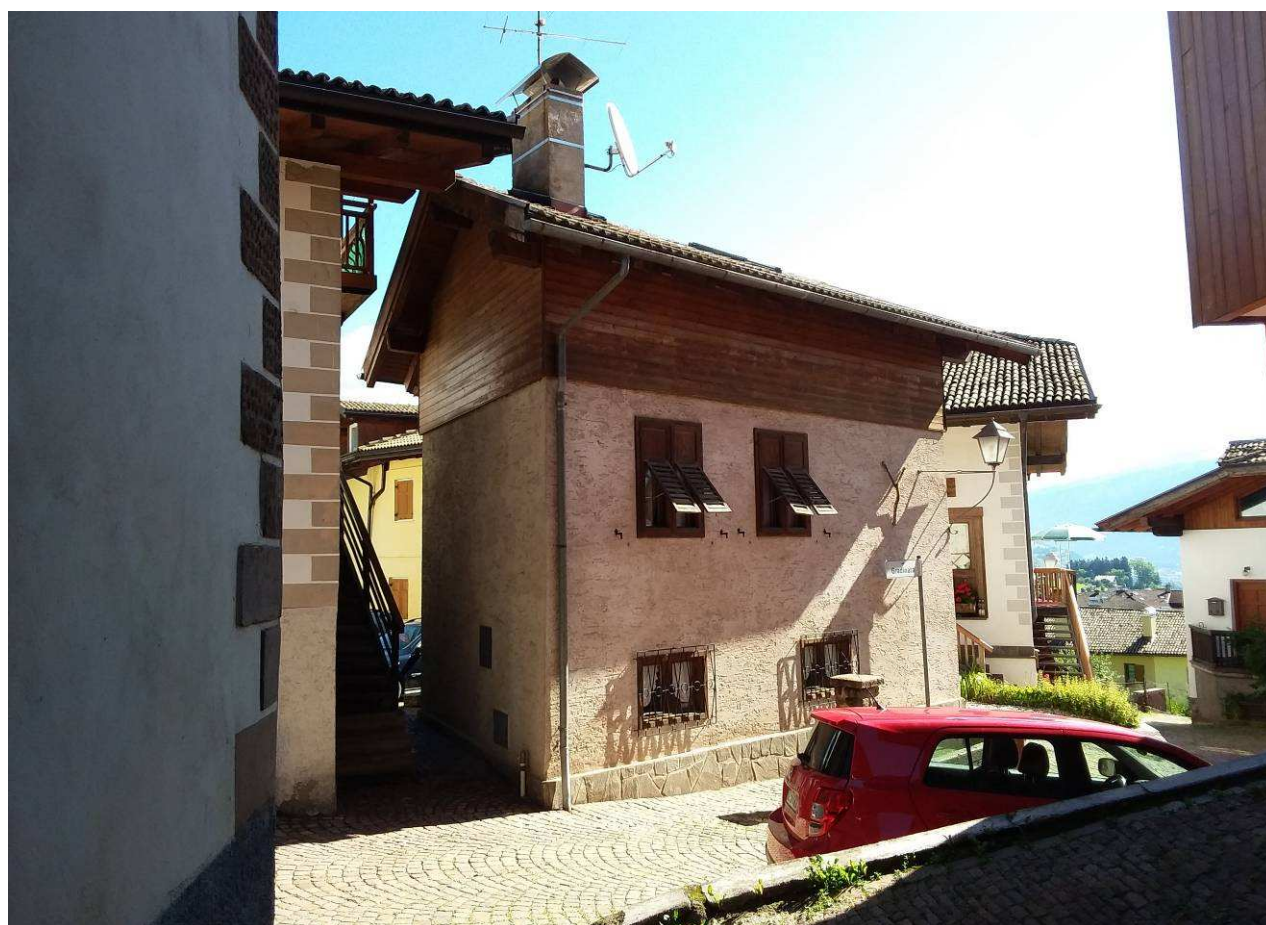
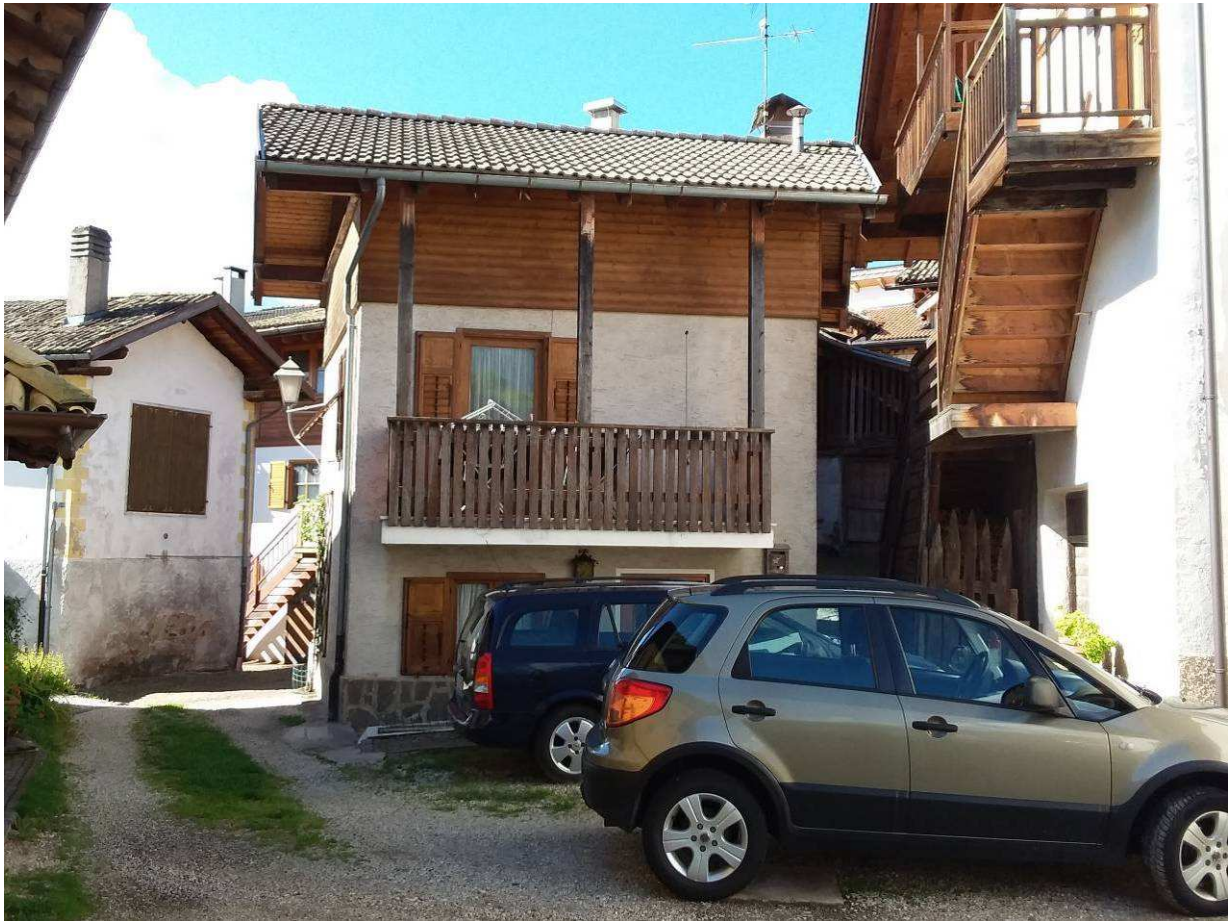
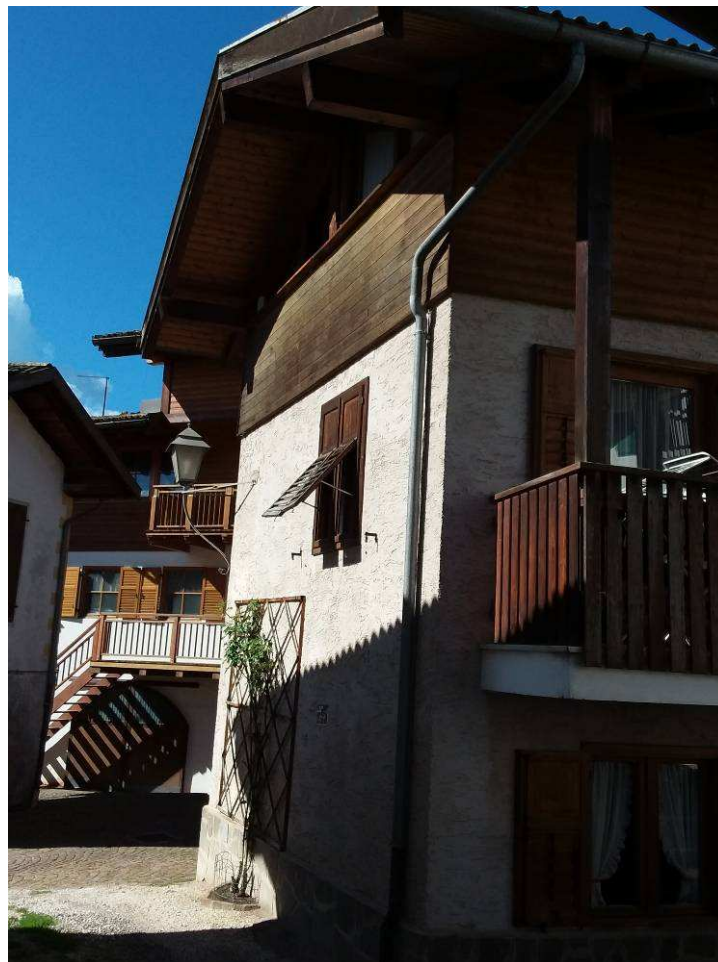
A photograph of a traditional stone building with a wooden balcony and a red fire hydrant in the foreground. The building has a light-colored stone facade and a dark wooden balcony. A red fire hydrant is visible in the foreground. The building is situated in a street with other buildings and a red car in the background.

| 5 | Degrado fisico | NULLO | | X | | | |
| 6 | Grado di utilizzo | UTILIZZATO | | X | | | |
| 7 | Spazi di pertinenza | ALTA QUALITA' | | X | | | |

| 11 | Categoria di intervento prevista | RESTAURO | X |
| 14 | Sopraelevazione per il recupero dei sottotetti a fini abitativi, ai sensi dell'art. 105 Legge provinciale 4 agosto 2015, n. 15. | SI | X |
